COLEMAN A. YOUNG MUNICIPAL CENTER

Americans with Disabilities Act Accessibility Compliance Review Report

Detroit-Wayne Joint
Building Authority

Project No. 1942.7050.00

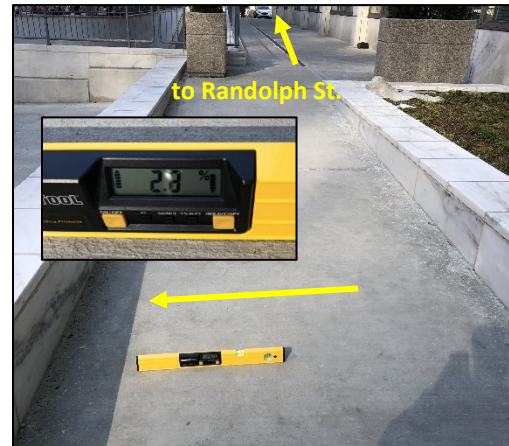
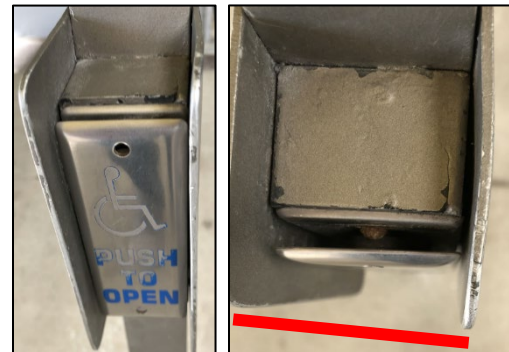
4. The longitudinal slope at the power-assisted door control outside of the E. Jefferson Avenue is 2.4% (2% max.).
5. The exterior power-assisted door controls at the E. Jefferson Avenue, Woodward Avenue, and Randolph Street entrances have the button recessed within barriers on each side. The narrow width of the barriers and depth of the recess may make it difficult for some persons with upper mobility impairments to operate the controller. The visibility of the power-assisted door controllers at all entrances except Randolph St. is low due to small size of the International Symbol of Accessibility (ISA) and loss of paint from the face. The Randolph St. entrance has a wall sign.

- The power-assisted door operators at the public entrances should be made more conspicuous with signage similar to that found at Randolph. Also, the power-assisted door operator buttons at the entrances at E. Jefferson, Woodward, and Randolph need to be made operable with a closed fist. Either the plates on the side of the buttons should be removed or the buttons made to extend beyond the front of the plates.

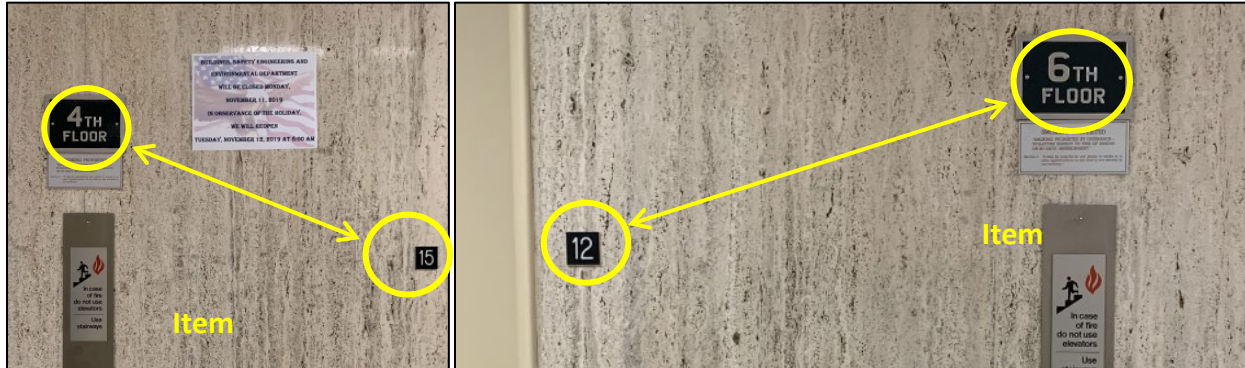
10. Existing elevator floor indicator numbers that are 10 or higher are comprised of 2 individual signs rather than a single sign. This results in excessive separation of the Braille elements. For example, at level 14, there is a '1' and '4' sign rather than a '14'. The Braille provided is technically the correct number but there is a minor issue with spacing when using numbering in this format.
11. The numbering of the elevators that is provided in the lobby could be potentially confusing to some members of the public, as the Elevator # and floor numbers are often in close proximity. Consider modifying the location of the elevator number labels to be less conspicuous (advisory only).

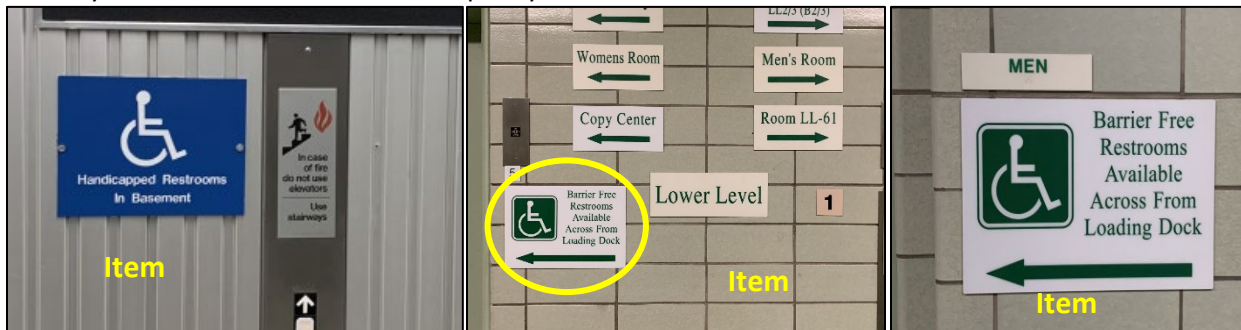
Examples of good location placement for informational/directional signage for accessible restrooms at the Level 1 Office Tower elevators, the Lower Level Office Tower Elevators, and Lower Level Men's non-accessible restroom in the Court Tower (Item 13).

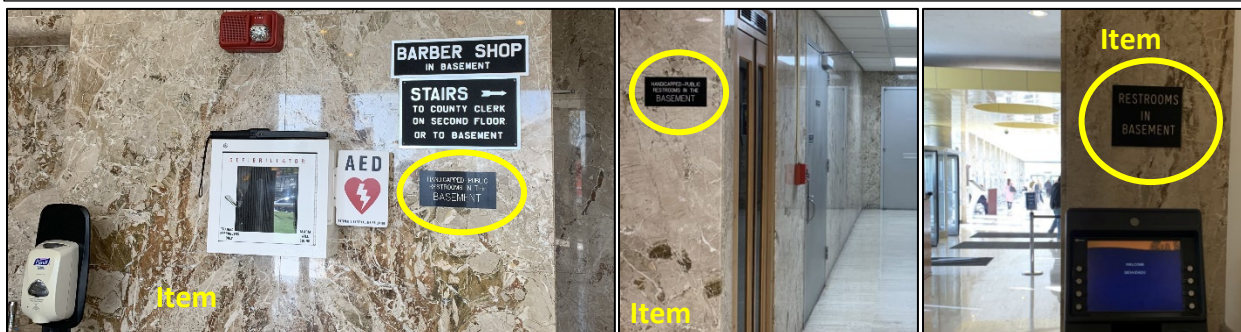
Examples of poor location placement and non-descript nature of visual signage for informational/directional signage for accessible restrooms well to the side of the Court Tower elevators, at the Level 1 Office Tower stairway corridor, and Level 1 Office Tower corridor pillar en route to building exit (Item 13).

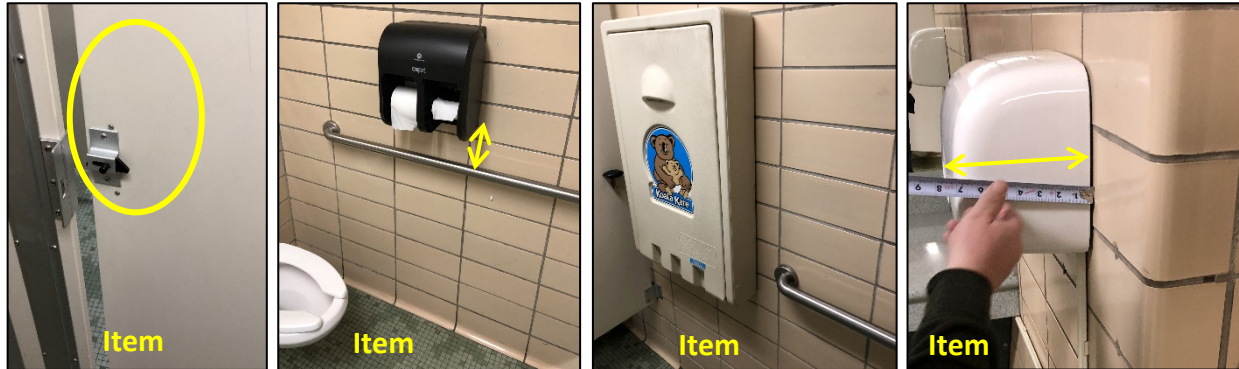
- b. the top lip of the lowest urinal is at 17-1/2" high (17" max. req'd.).

- c. the sinks provide only 5" deep knee space at 27" above the floor (8" min. req'd.).
- d. the wheelchair stall door provides no handle on the inside (handles required on both sides).
- e. the toilet paper dispenser is located 5" above the side grab bar in the wheelchair stall (12" clear space required above).
- f. the baby changing station protrudes more than 4" into the wheelchair clear space adjacent to the toilet.
- g. the hand dryer protrudes from the wall more than 4" into the circulation area within the room.
- h. the restroom has no ambulatory accessible stall, which is required when there are 6 or more total combined urinals and toilets (8 present in this restroom).

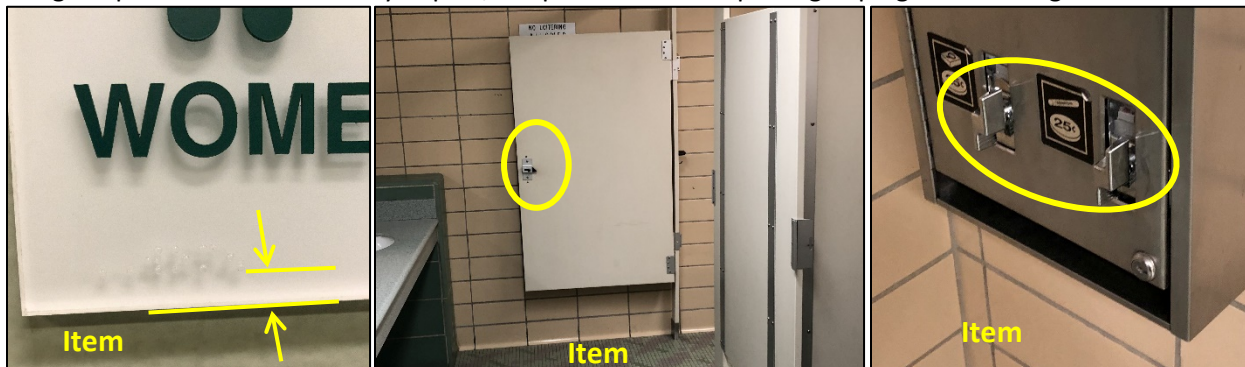
30. The accessible Women's restroom in the Lower Level has the following issues:

- a. non-compliant signage that provides only ¼" spacing between Braille and textile letters above (3/8" min. req'd.). The sign is also located to the left of the open doorway, consider signage on both sides of open doorways to restrooms.

- b. the sinks provide only 5-1/2" deep knee space at 27" above the floor (8" min. req'd.).
- c. the wheelchair stall door provides no handle on the inside (handles required on both sides) and the door is not self-closing (spring hinge needs to be replaced).

- d. the toilet paper dispenser is located 4-1/4" above the side grab bar in the wheelchair stall (12" clear space required above).
- e. the baby changing station protrudes more than 4" into the wheelchair clear space adjacent to the toilet.

- f. the hand dryer protrudes from the wall more than 4" into the circulation area within the room.
- g. operation of the sanitary napkin/tampon machine requires grasping and twisting.

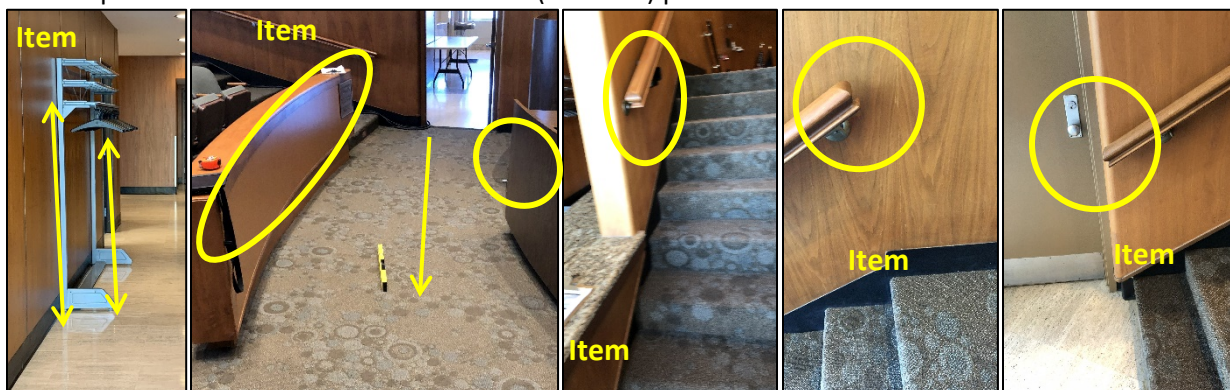
- There is no directional signage for the location of the wheelchair access into the auditorium via the side hallway and door.
 - The short ramp at the side door between the entry and wheelchair seating on the main floor has no handrails as required.

- Handrails present at the 4 sets of stairs from the hallway up to the auditorium level are not all full length on both sides of the stairs and do not provide the required 12" extension at the top parallel to the floor or 1 tread width (11" min.) past the bottom.

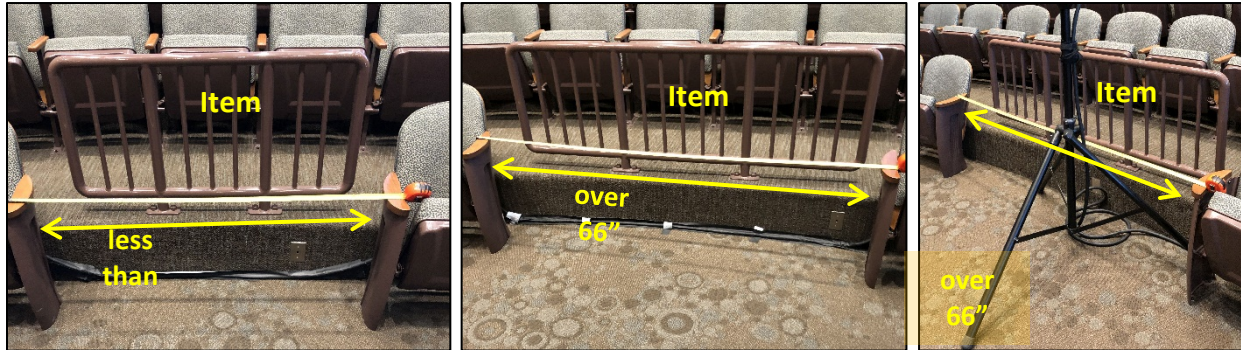
- f. Based on seating capacity (over 500 but less than 600) of both the 1991 and 2010 Standards, 7 total wheelchair spaces with adjacent companion seats are required but only 5 are provided. Two (2) of the existing spaces were blocked by a camera stand at the time of the evaluation.

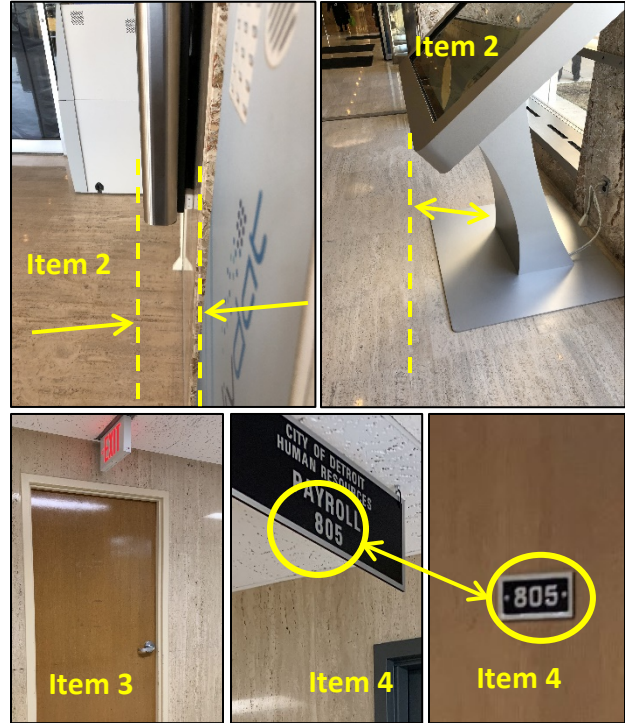
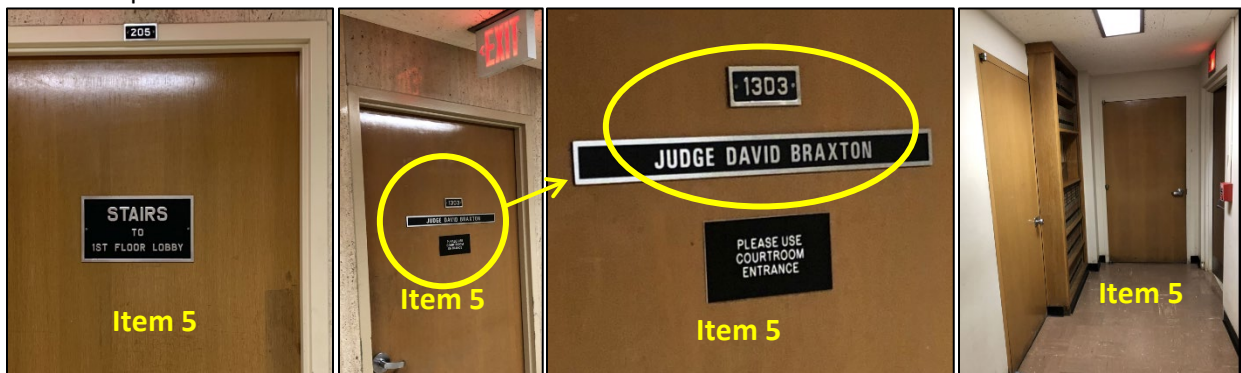
5. Most stairs are accessed from the public hallway via a door leading to a small foyer, which includes the stairway access door and often 1 or more other doors without signage. Some of these hallway doors include signage on the door about the non-stair space access beyond that could be confusing to the public.

Examples of hallway doors accessing the stairway foyer that include information about other spaces also accessed from the foyer. Rooms 203 to Stair A & Room 205 to Stair B (left photo) are two of the few doors with visual text that a stairway is beyond the hallway access door. Door 1303 is the access from the corridor to the Stair A foyer but includes visual signage for Judge Braxton (center 2 photos). Photo on the right shows a typical stairway foyer in the Office Tower, with the stair access door and 1 or more other doors with or without signs (Item 5).

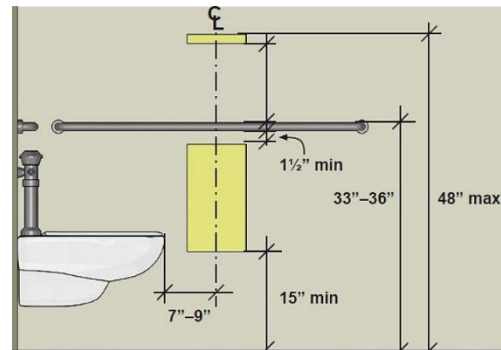
- The Men's restroom has a total of 8 combined urinals/toilets but no ambulatory accessible stall is provided. An ambulatory stall is required when there are 6 or more fixtures. Provide a compliant ambulatory stall in an existing stall by providing all required features, including 35-37" width and 60" minimum depth, 32" wide entry door with outswinging door, grab bars on both side walls, and other features as stipulated in ADASAD 604.

- Explore options available to provide additional accessible public restrooms throughout both towers. A partial evaluation was done during previous studies, which looked simply at modifying 2 existing stalls into a wheelchair accessible stall. A much more detailed investigation is needed, as spot checks of some existing non-accessible restrooms that were unlocked found fairly significant issues in addition to lack of a wheelchair stall. The investigation also needs to include an evaluation of fixture count requirements to meet current building codes, as well as other options that would accomplish the same goal of providing accessible restrooms such as adding family/unisex restrooms instead of modifying existing multi-user spaces. This would require evaluation of using existing space near existing plumbing infrastructure.

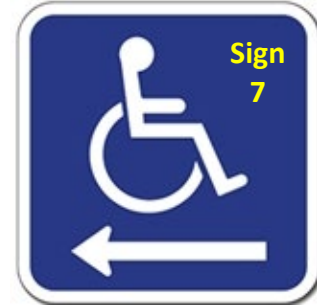
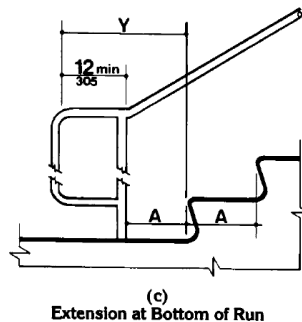
- Handrails provided at the four (4) sets of stairs from the hallway to the public seating area in the Auditorium have handrails that are not compliant. Existing handrails are not all full length of the stairs on both sides and none have the required extensions at the top and bottom of the stairs. The 1991 and 2010 standards both require handrails on both sides of stairs with extensions. The 1991 standards are more stringent with the requirements of bottom extensions (see comparison figures below). Installation of compliant handrails is not in itself a daunting task, however there are areas where the extensions will impact other features of the space. As shown on photos for Item 35d in Section 2.3, bottom extensions in some locations will obstruct access to doors for storage.

The height of some handrails is also an issue that will need to be addressed with the installation of new handrails. The top of gripping surfaces of handrails is required to be 34-38" above stair nosings

by both sets of ADA standards. Ensure that new handrails meet all requirements of ADASAD 505. It is recommended that the stair to the far right side when entering from the elevator lobby be corrected first, since there are no issues with conflicts at storage doors or incomplete sections of wall. The two sets of stairs in the center have doors to storage rooms on both sides at the bottom and the stairs on the far end have handrails on one side that are not the full length but have no issues with doors at the bottom landing. Signage similar to Sign 8 should be placed on the wall facing the elevator lobby doors directing the public to this set of stairs as the accessible stairs until all stairs can be made compliant. The signage should be blue in color and include the stair pictogram and directional arrow pointing towards with stair with visual text, with no tactile text or Braille required.

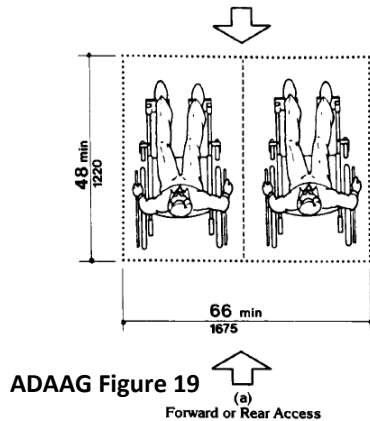
- Assembly areas are also required by ADAAG and ADASAD to provide accessible wheelchair locations. The number of spaces is dependent on the seating capacity, with both standards requiring 7 compliant wheelchair spaces [see ADAAG 4.1.3(19)(a) and ADASAD Table 221.2.1.1]. Compliant spaces are required by both ADAAG and ADASAD to provide 66" minimum width for 2 wheelchair spaces that are side-by-side for front or rear approach (see ADAAG Figure 46 and ADASAD Figure 802.1.2) and have a fixed companion seat next to each wheelchair space. ADASAD allows a single wheelchair space be provided that is 36" minimum width for front or rear approach. There are currently three (3) areas in the Auditorium that are provided for wheelchair seating. One nearest the accessible entrance and ramp is less than 66" but more than 36" and can accommodate one (1) space. The other locations are more than 66" wide and can accommodate two (2) spaces each, providing a total of 5 compliant spaces. However, at the time of the evaluation, the spaces furthest from the accessible entrance were obstructed by a camera stand. Signage at designated companion seats should be provided similar to Sign 9. Explore options

available to provide an additional two (2) compliant wheelchair spaces with companion seating and relocate the camera that obstructs the existing wheelchair seating area.

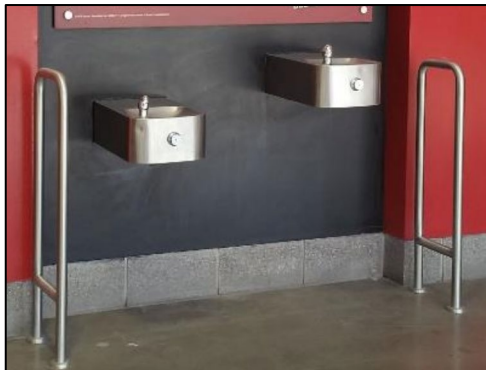
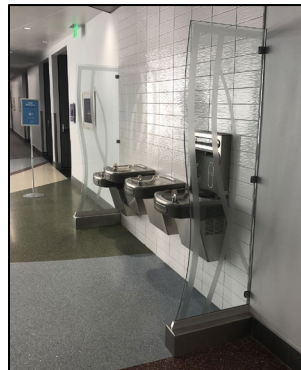
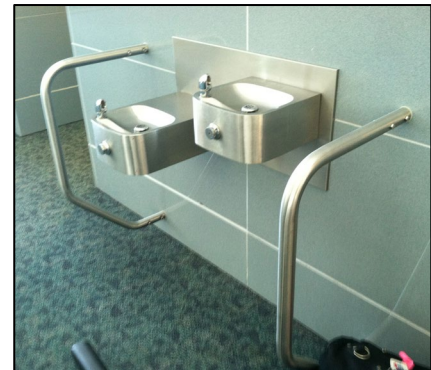
providing a bubbler height of 36" maximum above the floor and knee space below that is not available at the original fountains. Unfortunately, the alcove in which these new fountains have been placed are too shallow and all of them are protruding objects. Some were installed with knee space below that is less than 27" and need to be adjusted to meet requirements. One option for the protrusion issue is to install cane-detectable railings on the side as necessary (see examples below).

Examples of artificial alcoves constructed at protruding drinking fountains.

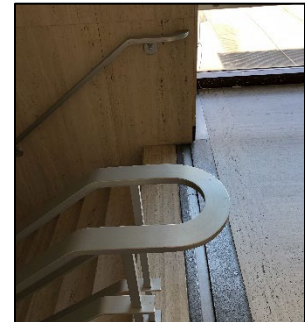
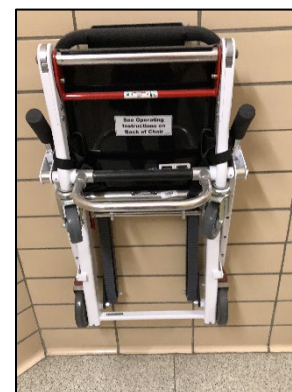
- There were issues noted at several locations where stairs and handrails are not compliant within stairwells and at hallways connecting multiple levels of the towers (Court Tower Level 13 and Court Level 11/Office Level 10). Handrails can be important for persons that are able to use steps but need assistance. Explore options to provide compliant handrails at proper height and with required extensions at the top and bottom. One set of stairs, located at Level 12, has compliant handrail extensions (see photo to right). As noted in Section 2.2, Items 3 and 28c, and Section 2.3, Items 28c, 29, and 30c, stair nosings project over the risers at a 90 degree angle. This is a common issue at older buildings and commonly addressed by installation of stair tread covers that reduce the angle as well as provide a non-slip surface. There are many different covers available, see example photo to the right.

- There were a total of three (3) wheelchair evacuation chairs observed within stairwells of the facility. A chair was on Level 1 of both towers and Level 13 of the Court Tower. DWJBA is to be commended for providing these important pieces of equipment that are used to evacuate persons in wheelchairs down the stairs in the event of an emergency (e.g., fire) where the elevators are shut down. Consider reviewing existing emergency evacuation plans (not included within the scope of this project review) to ensure that procedures are in place to communicate the need for evacuation chairs. Consider the best locations to place the chairs, which is not at Level 1. It is much easier to move the chair down the stairwells to assist with evacuation than to carry them up the stairwells. There are no ADA requirements for these devices. It is recommended that all floor captains or fire wardens be made aware of the location of chairs and that chairs currently in place on Level 1 be moved to Level 13 of the Office Tower and a higher level in the Court Tower. When considering placement within the Court Tower, determine the levels with the highest occupancy loads. Additional chairs could be considered to cover all 5 stairwells, though Stairs A and B in the Court Tower and Stairs C and D in the Office Tower are close to one another. Consider perhaps an additional chair at Stair E, which is somewhat isolated on many levels.
